Ergonomics Good Practice Case Study

Construction Sector

JJ Rhatigan & Company

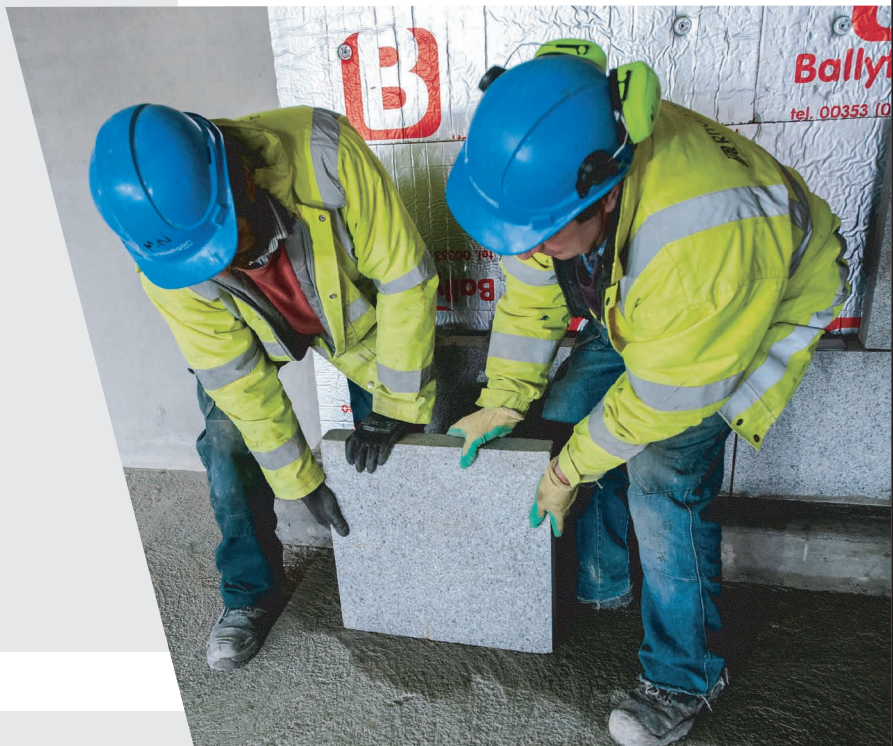
- Awkward posture while holding the stone cladding unit in position at the building façade
- The weight of the stone cladding units (up to 144kg load weight) and the upper arms are angled away from the body and the trunk is bent forward
- Twisting postures while manoeuvring and aligning the stone cladding units prior to installation
- Lifting heavy stone cladding units from the trolley/scaffold up to chest height

A new office building was being constructed in Galway City; the building design specified that large stone cladding units were to be installed and fitted to the facade of the building. The stone cladding units were large and heavy, varying from 19.4kg to 143.7kg. A specialist sub-contractor was procured by the company Project Supervisor Construction Stage (PSCS) to install the stone cladding units on site. The sub-contractors initial proposed system of work was based on the long-established traditional methods of manual transfer of each stone cladding unit from a pallet on the loading bay onto a trolley and then a two-person manual lift (and hold) during the final placement of stone cladding in the building's facade.

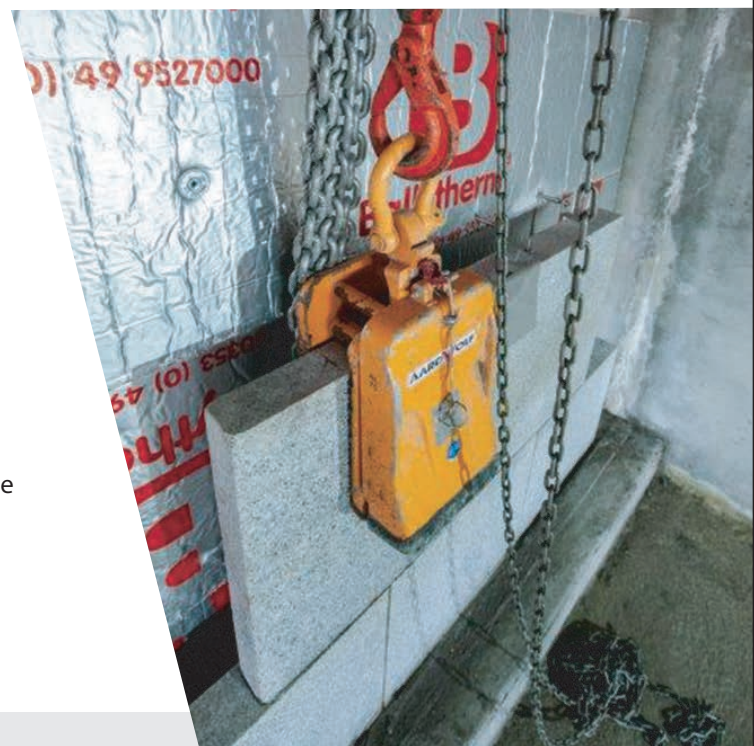
A bespoke certified mild steel cantilever bracket was manufactured and hung from the top of the wall and secured into position. A chain block was then attached to the cantilever bracket with a certified D-Shackle connection and the Lifter/Grab was then attached to the chain block using designated attachment points. The cantilever bracket was moved horizontally along the top of the wall as the stone cladding progressed.

The introduction of the chain block and Lifter/Grab eliminated the manual lifting of very heavy stone cladding units and avoided the need for sustained awkward bending and twisting postures that resulted from the manual installation process.
